Motorcycle accidents – case studies and what to learn from them

Ecker, H.

Vienna University of Technology,

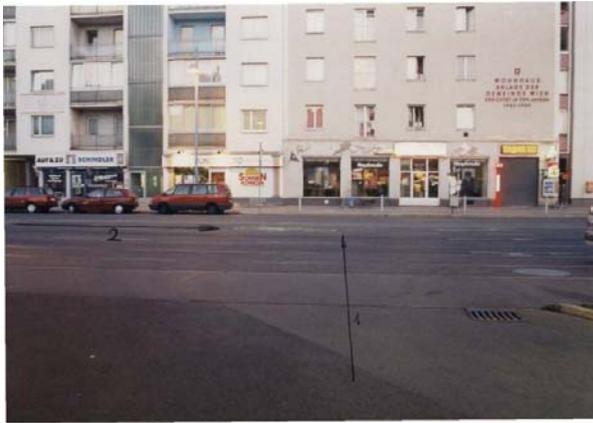
Figure 1

A driver refueled his compact car at a gas station and drove away from the place via one of the exits, see Fig.1. Instead of turning right at the exit, as a road sign near the exit dictates, he crossed the adjacent three traffic lanes and stopped at the double-lined median of the road, see Fig.2. When he was about to cross the double-line, not in keeping with the regulations, a motorcycle approached the car from the left. The rider, driving along the road as shown in Fig.2, tried to stop his bike, but the braking manoeuvre was not successful and he crashed into the car. The driver of the car was unharmed; the motorcycle rider was lucky and suffered only from minor injuries. See Figures 3 and 4 for the severe damages of the vehicles.

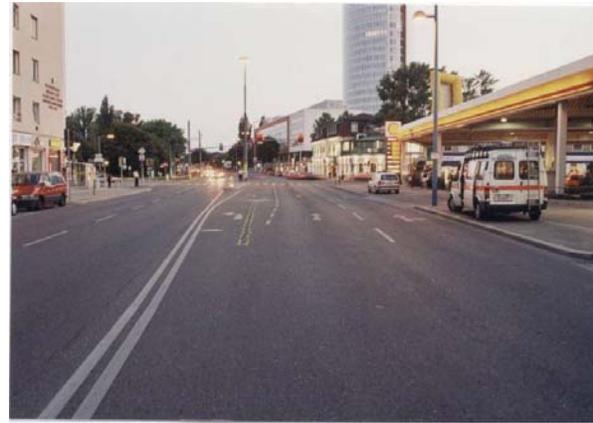
Figure 2

There is no doubt that the car driver did break the traffic regulations by crossing the road instead of turning right. His traffic violation was the primary cause for this accident. There is, however, also the question, whether this accident could have been avoided by the motorcycle rider. As one can see from Fig.2, it might have been possible for the motorcycle rider to see the car crossing the road early enough, to start a braking action and avoid the accident. Whether the accident was avoidable for the bike rider or not, is a question of timely (or delayed) reaction time, of proficient operation of the brakes and, last but not least, of the velocity on approaching the scene. Skid marks produced by the rear tire of the motorcycle and the deformations of the vehicles did suggest that the speed of the motorcycle was, at least, above the maximum speed allowed on this road. Also the skid marks did show that the braking manoeuvre was aborted several meters before the crash. The motorcycle rider did give evidence that he wanted to make a swing to the right to avoid the crash and pass behind the car. This evasive action was started too late, to be successful. Therefore, excessive speed of the motorcycle and possibly also the inappropriate braking action of the rider contributed to the accident.

Many motorcycle accidents are triggered by wrongdoings of other road-users. Knowing that an accident wasn't his or her fault might give a motorcycle rider some satisfaction, but this does not really relieve the pain from injuries. Therefore, assuming that others make errors and violate traffic regulations, and taking this into account when driving, is mandatory for a long life as a biker. Some situations cannot be anticipated even with a sixth sense in situation awareness. In such a case it pays off being slow and knowing how to operate one's bike. Proficiency can be a life saver and something every motorcyclist should work on constantly..

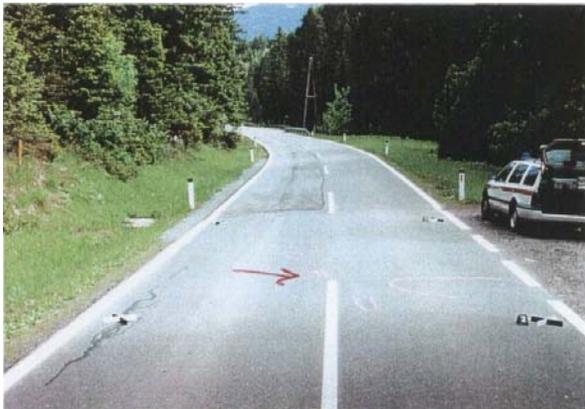
A motorcycle rider was driving on a country road. While following the road, which makes a gentle right turn, he approaches a bicycle rider from behind. Figure 5 was taken in opposite direction of the direction the bike and the bicycle were going and shows the right turn of the road in the background. As the motorcycle rider wants to pass the bicycle rider, both riders and vehicles collide and slide off the road into the grass. Both accident victims were severely injured and have no memories of the accident. Skidmarks and traces of fluid, which had escaped from the motorcycle were found on the road, see red markings on Fig. 6. Windshield, head lamp and instrument panel of the motorbike were almost completely destroyed by the collision, as shown in Fig.7. The bicycle was deformed and bent, with a cracked frame and a sheared off left pedal, see Fig. 8.

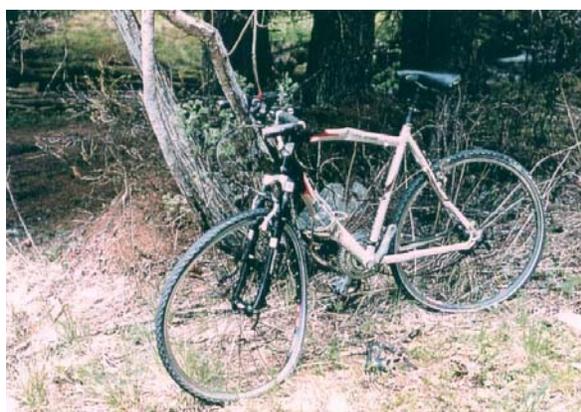
Figure 8

traffic timely. The motorcycle rider probably did maintain an appropriate speed. Since there is no evidence of a braking manoeuvre of the motorcycle, the rider was either surprised by the action of the bicycle rider or tried to make an evasive manoeuvre, which failed. Direction of sunlight in combination with tall trees next to the road might have created shadows on the road, making it harder to recognize a bicycle in the dark. One of the questions in the course of the accident investigation was, if the possibility exists that the bicycle rider did maintain a straight direction and that just a grazing contact occurred, due to careless passing of the bike rider, i.e. with a lateral distance being too small. Rubber marks on the bicycle frame, originating from the bike's front tire, did show that this assumption is very unlikely.

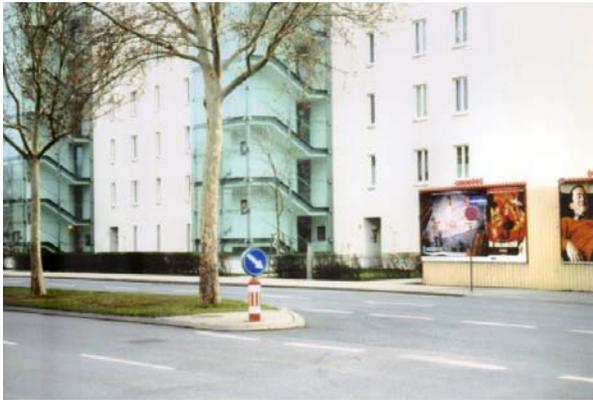
Figure 9

A motorcycle rider stopped close to a traffic sign at a road intersection of a two-lane downtown road, see Fig. 9. When there was no more traffic coming from the right, she accelerated her bike to turn left onto the two-lane road. For some unknown reason the motorcycle rider lost control of her bike. Still struggling to stabilize her motorcycle she crossed the walkway one can see in Fig. 10, and barely managed to avoid fully hitting the concrete column. Contact was made however, by the left foot and the footrest. The wild ride ended beyond the hedge on the small lawn. Feeling pain in her left foot the biker took off her left boot and noticed with horror that one toe had been cut off by the accident.

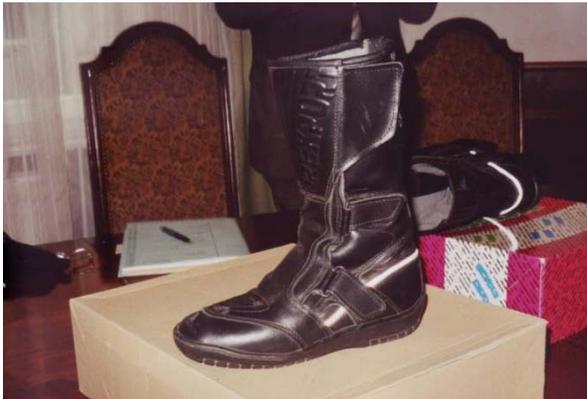
Figure 11

It was not possible to find out why the motorcycle rider lost control of her bike. As she did not, or did not want to remember what happened initially, this is left in the dark. There is a conjecture that the side stand has been extended during the stop, but not retracted when moving on. However, this possible cause could not be proved. The seemingly more mysterious fact is the severe injury the lady suffered from the accident. The left boot seems to be fully intact, see Fig. 11, and does not give a clue on how this could have happened.

This is a very unusual and strange accident, but it did happen. It underlines that wearing good quality cloths and boots is definitely worth the money in case of an accident. Although the boots of this case look and feel as if they were robust and sturdy, they did not protect the foot as expected. Of course, boots cannot withstand all kinds of forces and at any level. But in this case the sole not only collapsed but also formed a dangerous shape that finally caused the most severe injury of the motorcycle rider. Without a detailed accident database available it is impossible to tell, whether this is a one-of-a-kind traffic accident or not. Therefore, it would be already quite helpful to make accident reports accessible to the public via Internet or any other method of communication. This could help to identify and find out about products that are dangerous rather than protective for their users.

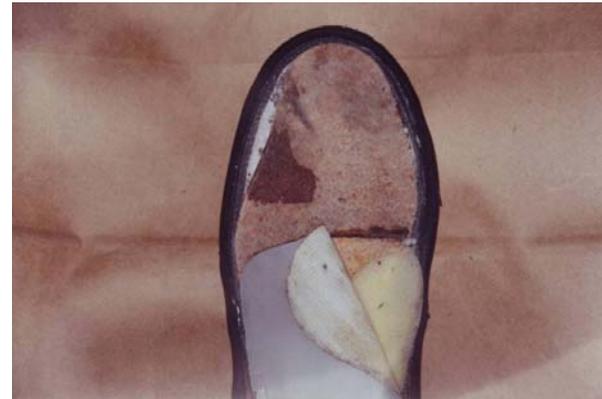
It was necessary to cut off the upper part of the boot from the sole and this did reveal what had happened. Obviously boot and foot were squeezed between the concrete column and some part of the motorcycle engine or frame. The sole did not withstand the lateral pressure and did collapse, which means break and fold. The sole is composed of different layers, with the one on top being made from a rather thin but stiff material. This top part of the sole separated from the layers below and folded upwards on the outer (left-hand) side. The folded up section of the sole was sharp and stiff and acted like a knife, which literally did cut off parts of one toe. Figure 12 shows a dark spot on the sole in the area where it was folded up by the accident. The dark color comes from blood which escaped from the wound. It was possible to reproduce the folding behaviour of the sole in laboratory experiments and prove that, in certain situations, this motorcycle boot can be harmful to the person wearing it.
